M/037/022

Inspection Report

Case File: Small Fry Mine Closure
Inspector: Denice Swanke, Physical Scientist
Date of Report: 15 April 2002

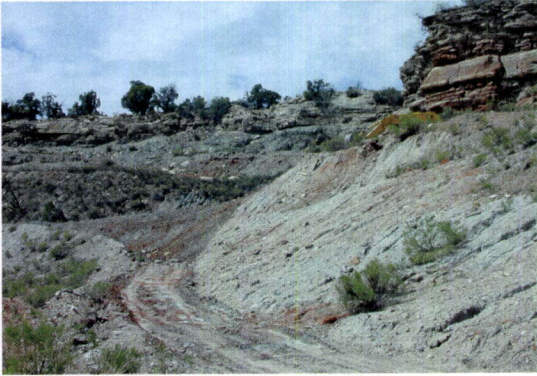
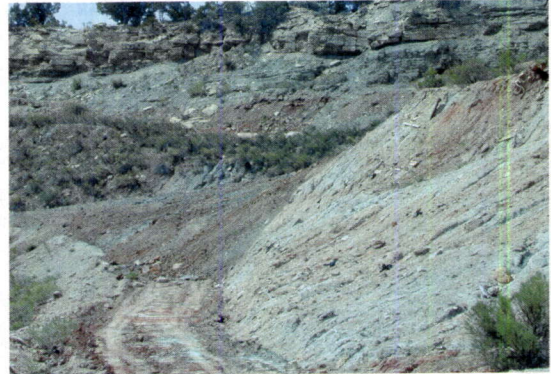
After leaving the shaft site I walked the portal site, taking photographs of several worked areas. My camera batteries died, so 2 photographs of portals which are adjacent to the mine road did not come out, those portals have been filled, and will be covered thoroughly with dirt as the road surface is worked back to the N-NE. The Harding ESE equipment operator, David, was breaking down the hillside which divides the upper road and lower road to the pad while I was there. Dirt was being removed from the hillside and deposited onto the lower road.

Photos 1-2: Closed portals below rim, active reclamation of hillside and lower road to pad.

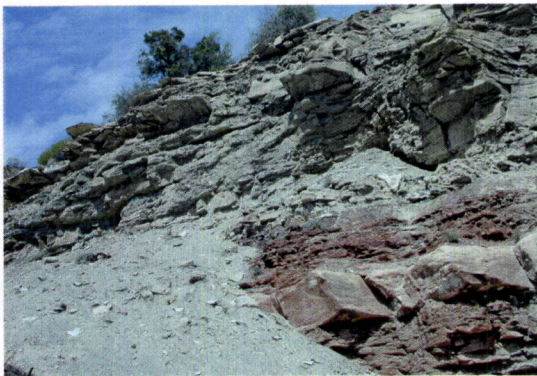
Photo 3: Closed portal.

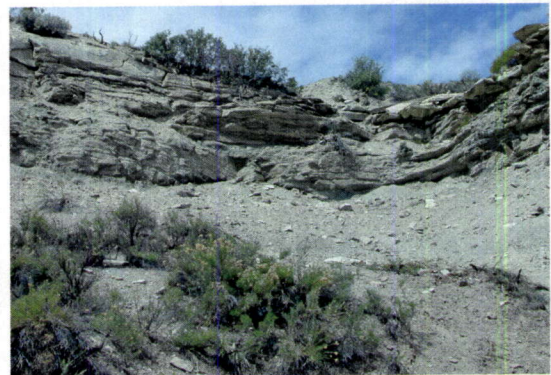
Photo 4: Closed portals.

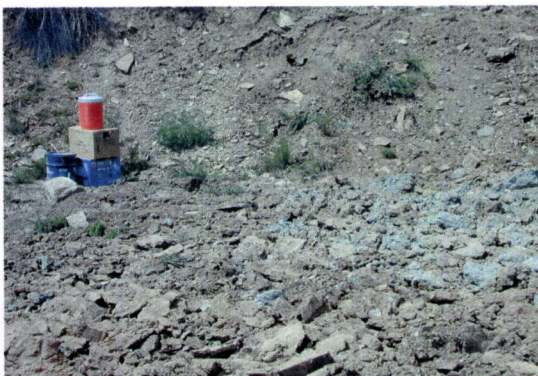
Photo 5: Ripped surface, former staging area.

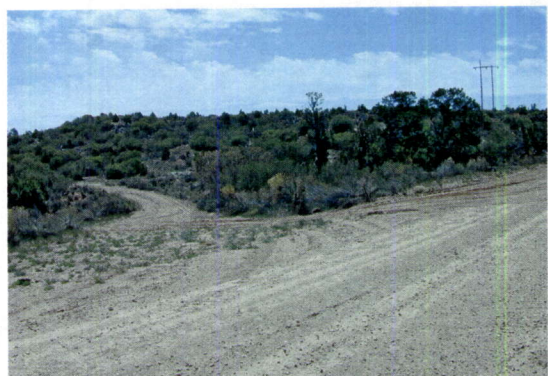
Photo 6: View of access road off CR114.

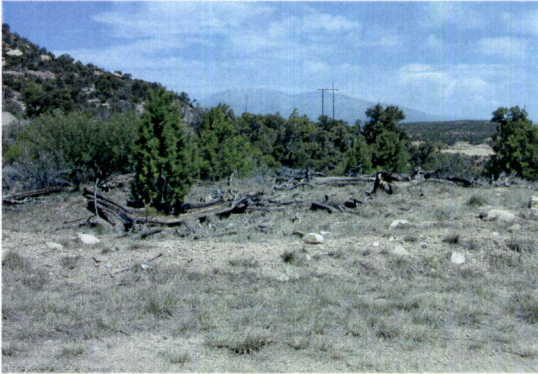
Photo 7: View to the NE from the access road, note chaining, present along entire road.

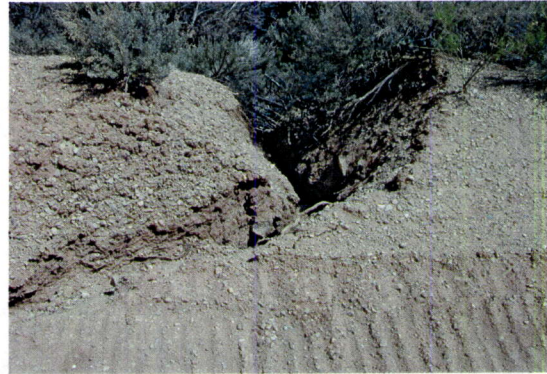
Photo 8: Erosion on N side of access road.

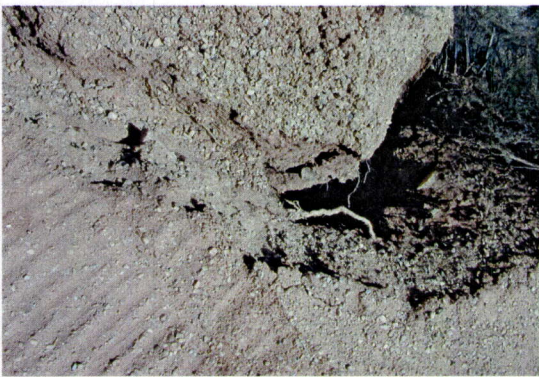
Photo 9: Erosion on N side of access road.

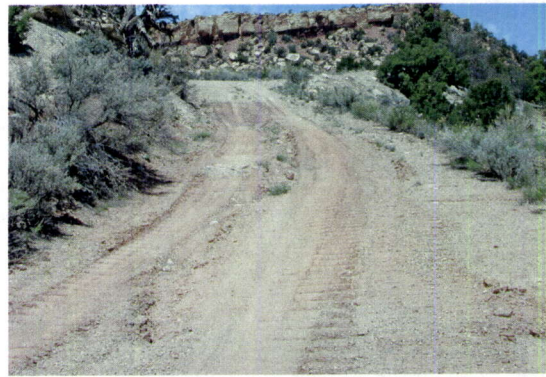
Photo 10: View to N-NW of access road.

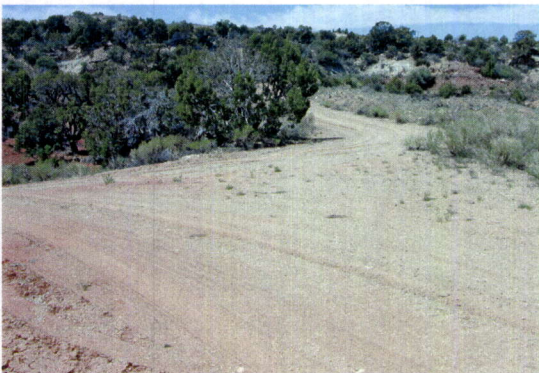
Photo 11: Junction of mine spur road and the access road.
Road in foreground returns to Big Indian road, road in distance (also shown in photo 10) goes W short distance to CR114 (shown in photo 6).
